QUARRY RESIDUALS OPERABLE UNIT INTERIM REMEDIAL ACTION REPORT

WELDON SPRING SITE REMEDIAL ACTION PROJECT
WELDON SPRING, MISSOURI

NOVEMBER 2003

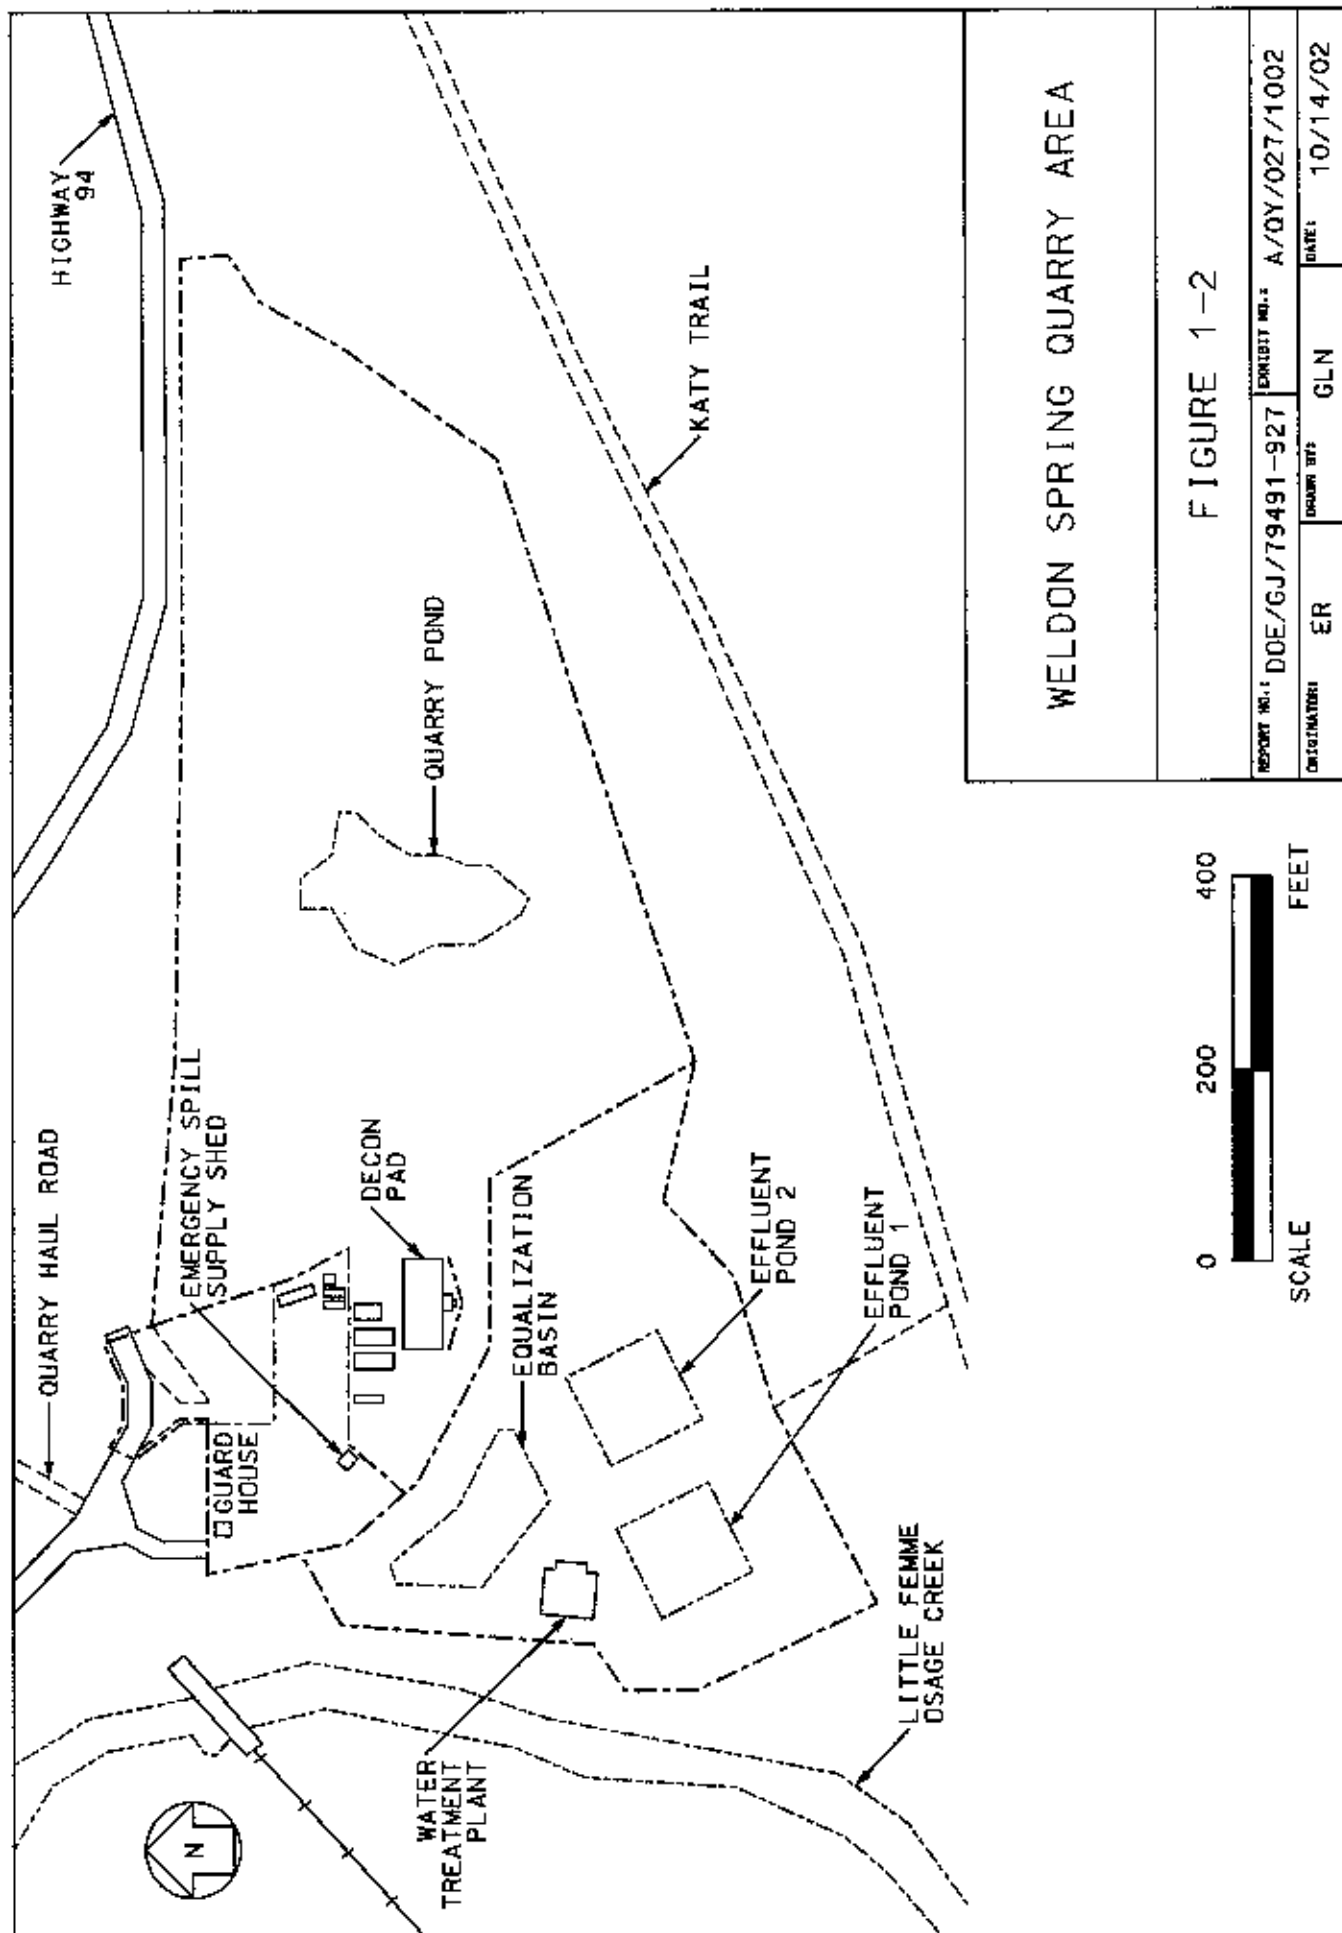
FIGURE 1-2

WELDON SPRING QUARRY AREA

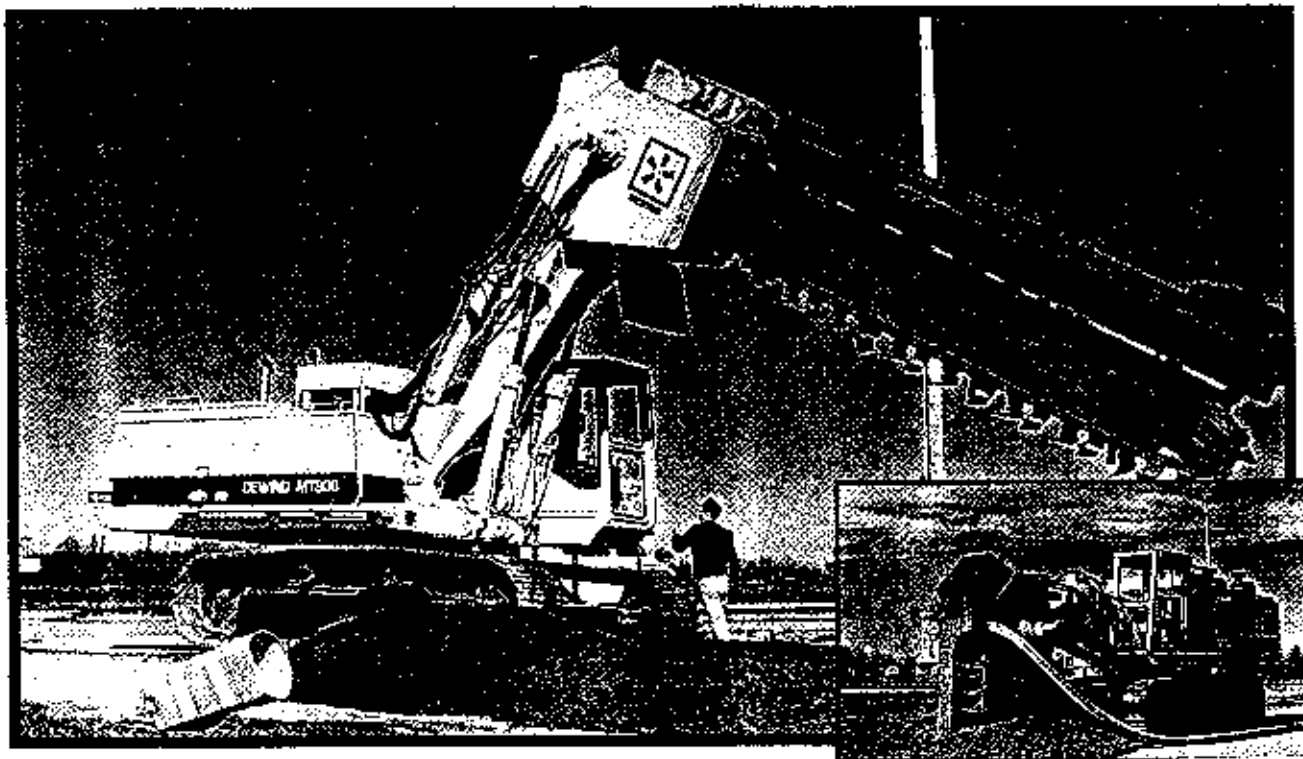
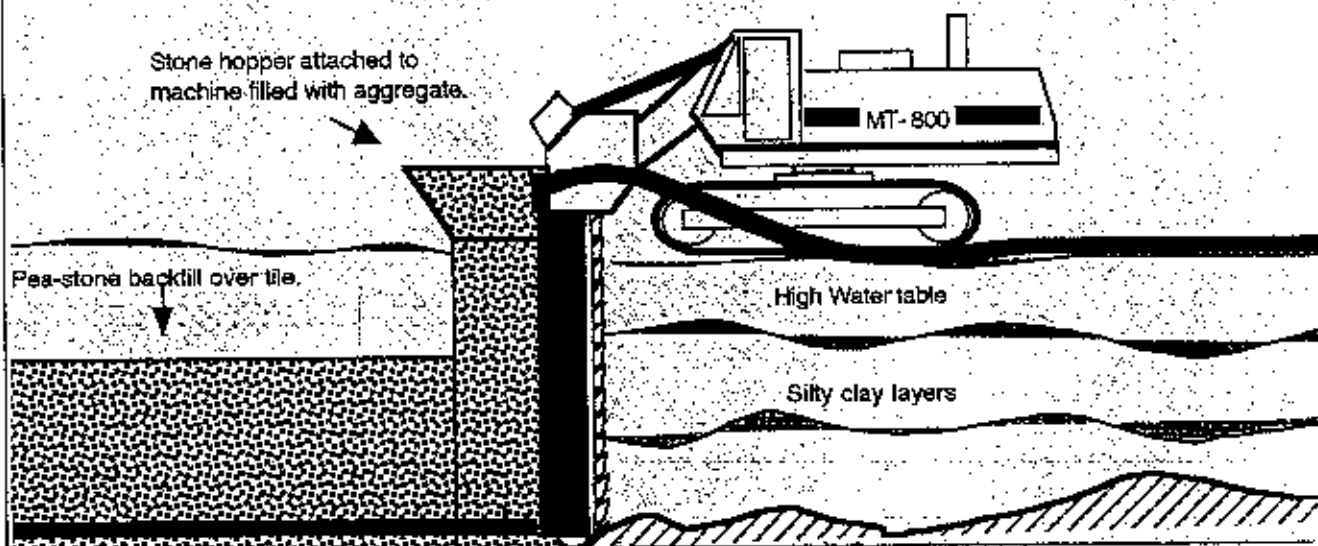
FIGURE 3-1

The activities began on January 27, 2000, and were completed by May 5, 2000. Per the subcontract specifications, the area where the interceptor trench was to be located was topographically surveyed. After the layout of the trench was marked, the area was cleared, grubbed, and graded so that trenching equipment could access and install the interceptor trench. On February 15, 2000, an "all-in-one" trencher (MT 800) was mobilized at the Quarry by Dewind Dewatering Inc. The trencher was used to excavate to the top of bedrock, place 3 in. high density polyethylene (HDPE) dewatering pipe, and backfill the interceptor trench all in one pass (Figure 3-1). Pea gravel was used as the backfill material and the trench was backfilled within 3 ft. of the ground surface. To ensure that the subcontract specified drainage pipe depth was maintained, a laser guide mounted on the MT 800 was used. Within three days, the MT 800 was able to install and backfill 550 ft. of drainage pipe.

MT800 TRENCHER

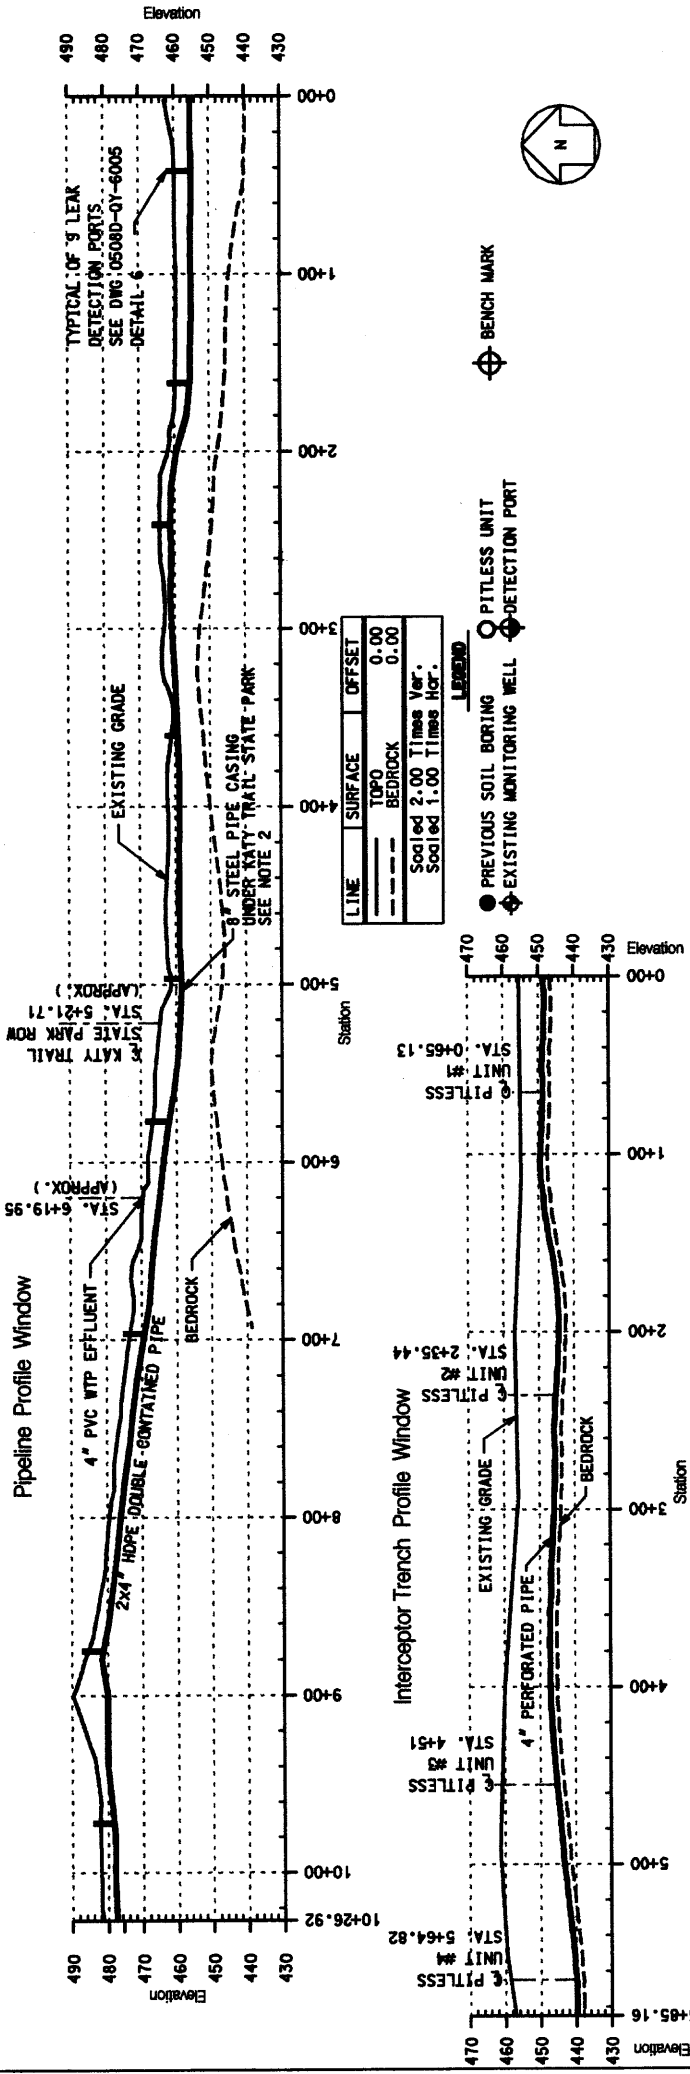
FIGURE 3-2

After the trencher was demobilized, four extraction wells were drilled through the trench and 1-ft into the underlying bedrock and four pitless unit pumps were installed. A utility trench 42 in. in depth was excavated adjacent to the interceptor trench. Process water lines from the pitless units and electrical conduit were placed in the trench. The process water lines ran into an underground valve vault (south valve vault) and merged into one double-walled HDPE pipe (2 in./4 in.). The double-walled HDPE pipe was pressure tested prior to backfill. The double-walled pipe ran from the south valve vault to another valve vault (north valve vault) located east of the QWTP effluent pond #2 (Figure 3-2). Leak detection ports were installed in the double-walled pipe to detect any potential leak of contaminated groundwater.

INTERCEPTOR TRENCH

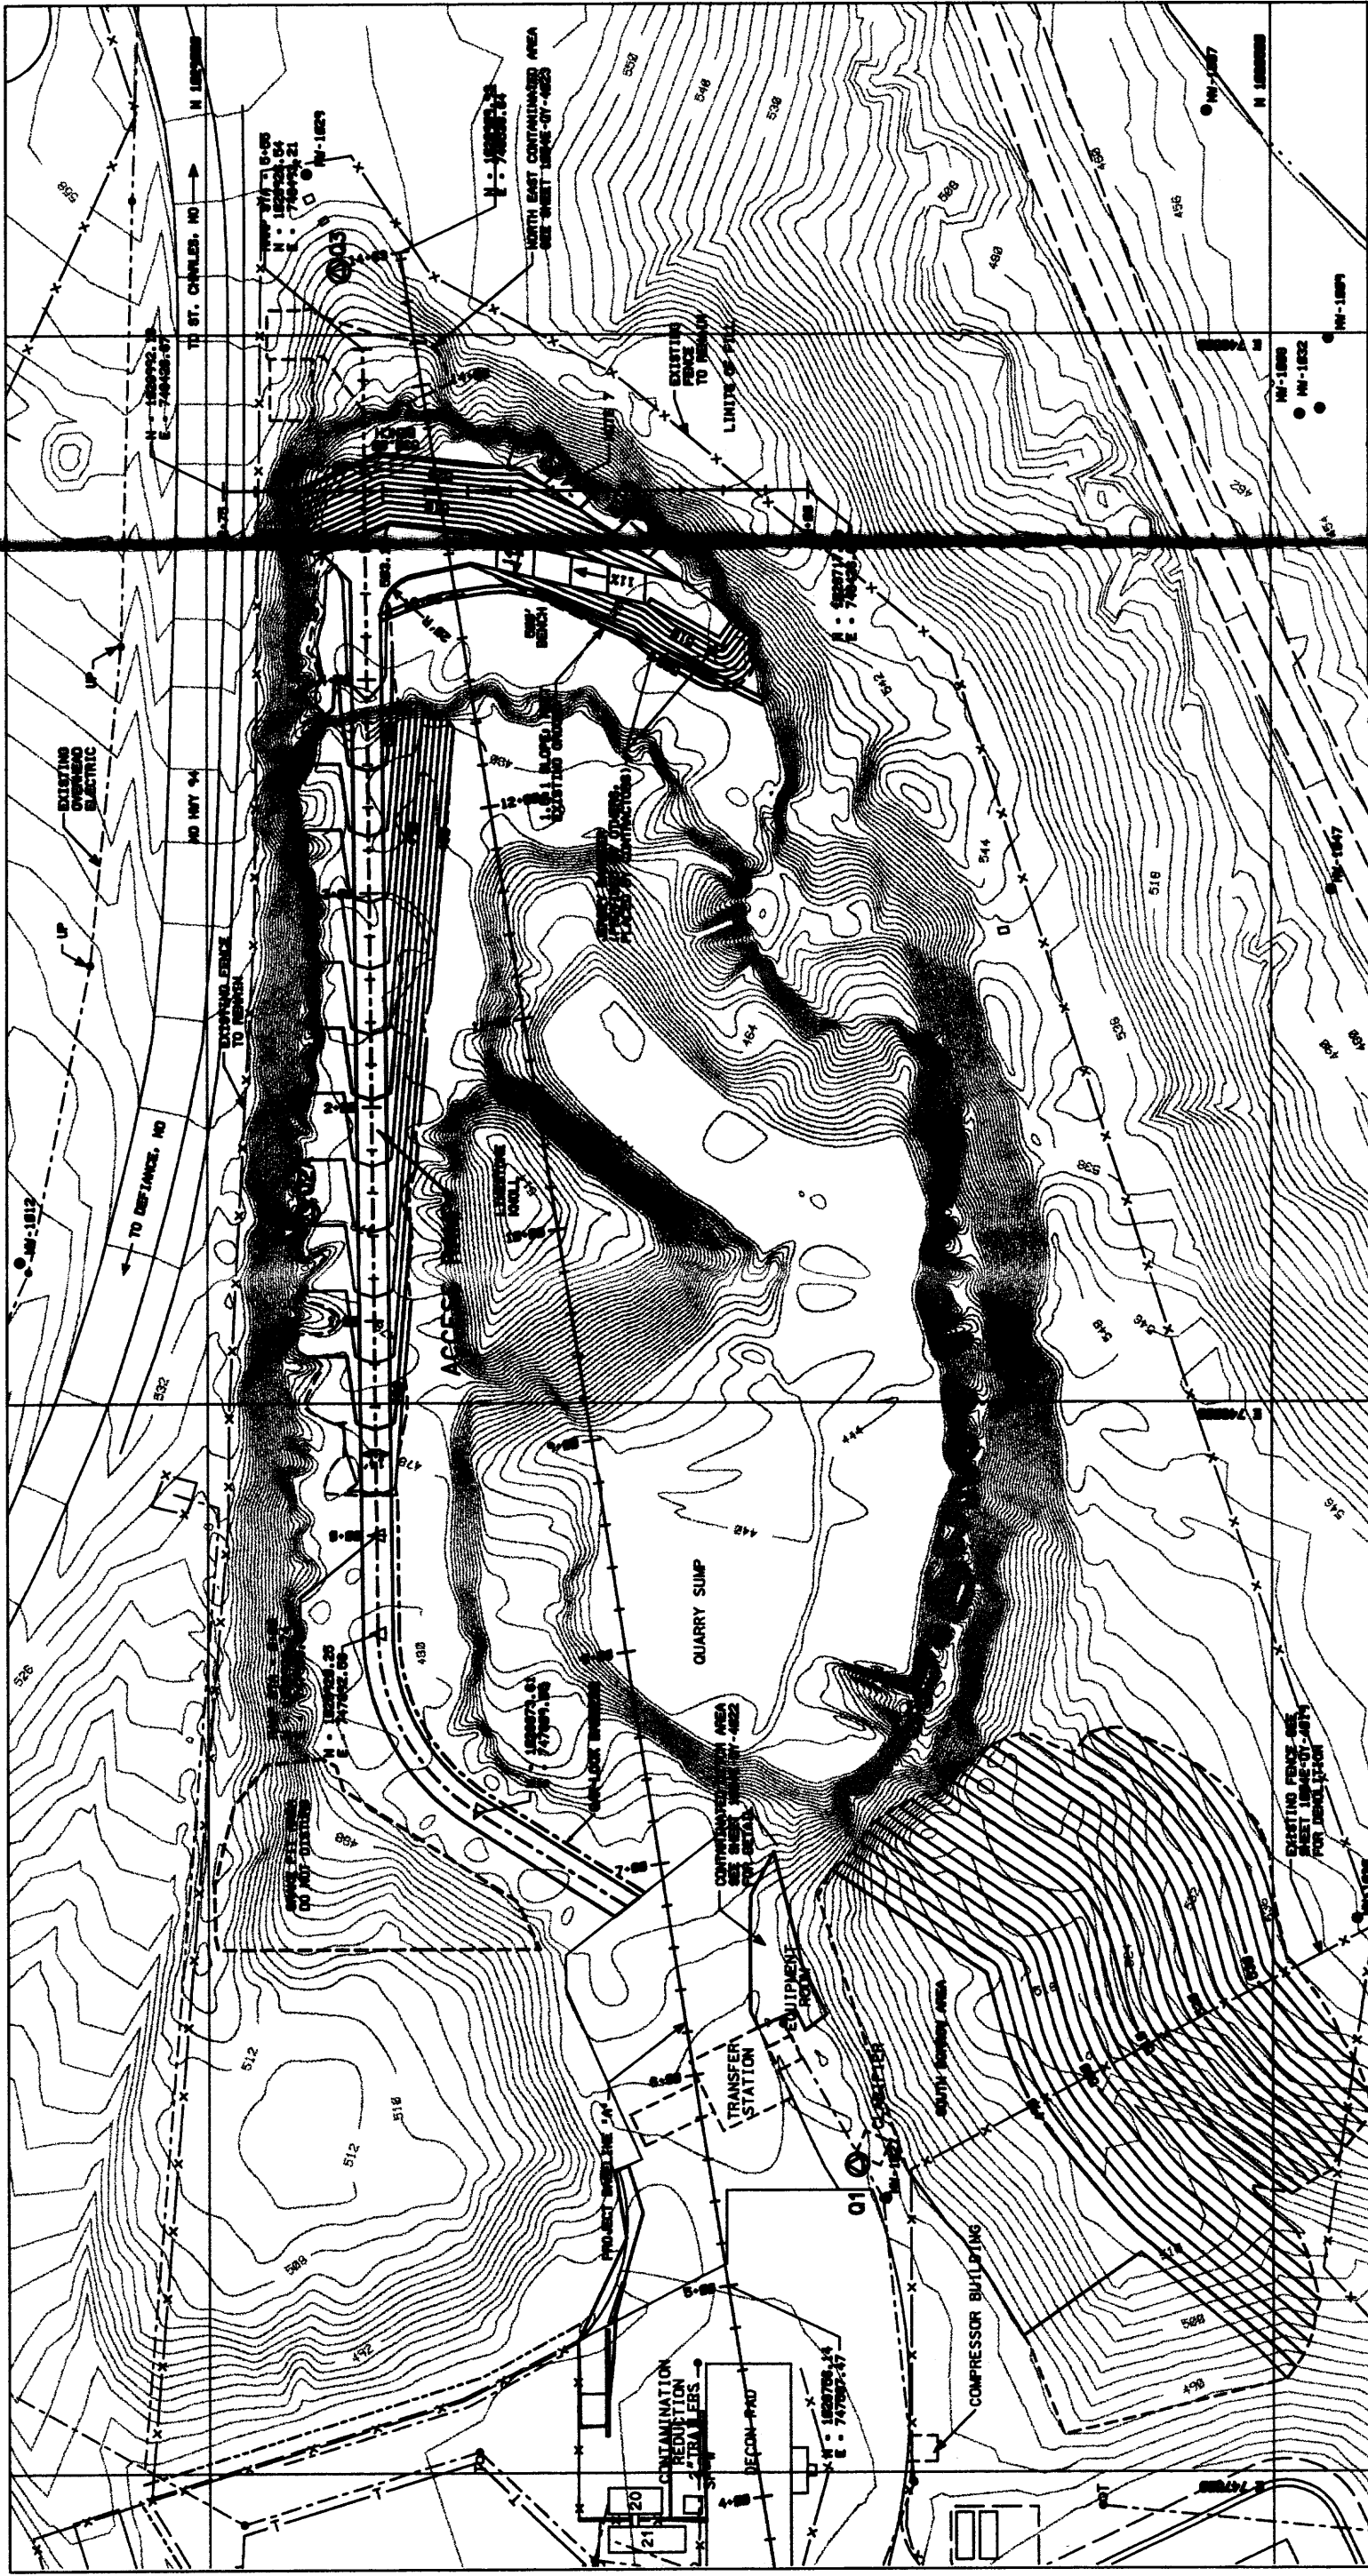
FIGURE 3-4

QUARRY FRACTURE LOCATIONS

- 70 FRACTURE (WITH FRACTURE NUMBER)
- 71 FRACTURE TO BE FILLED WITH LOW PERMEABILITY SOIL
- 72 FRACTURE TO BE FILLED WITH GROUT OR CONCRETE

As the access ramp was being constructed, multiple fractures in the Quarry floor and highwall were sealed with clay backfill, shotcrete, or concrete. These fractures were designated by the numbers 66 through 89 and are detailed in Figure 3-4. Fractures on the floor were filled with clay and compacted with a vibratory plate attached to a Caterpillar 322B excavator. Attempts at using shotcrete (concrete applied by spraying) to seal the vertical fractures on the Quarry highwall were, for the most part, unsuccessful. The shotcrete would adhere to the highwall until it became too thick and then fall to the ground. The subcontract specifications were changed so that the vertical fractures would be blocked with plywood and sealed with concrete. The plywood prevented the concrete from running out of the fracture and provided more efficient sealing of the fracture. Five fractures on the north side of the quarry were deleted from this package because they were too high in elevation to use plywood forms rather than shotcrete. These fractures were later added to WP-551A (Section 3.6).

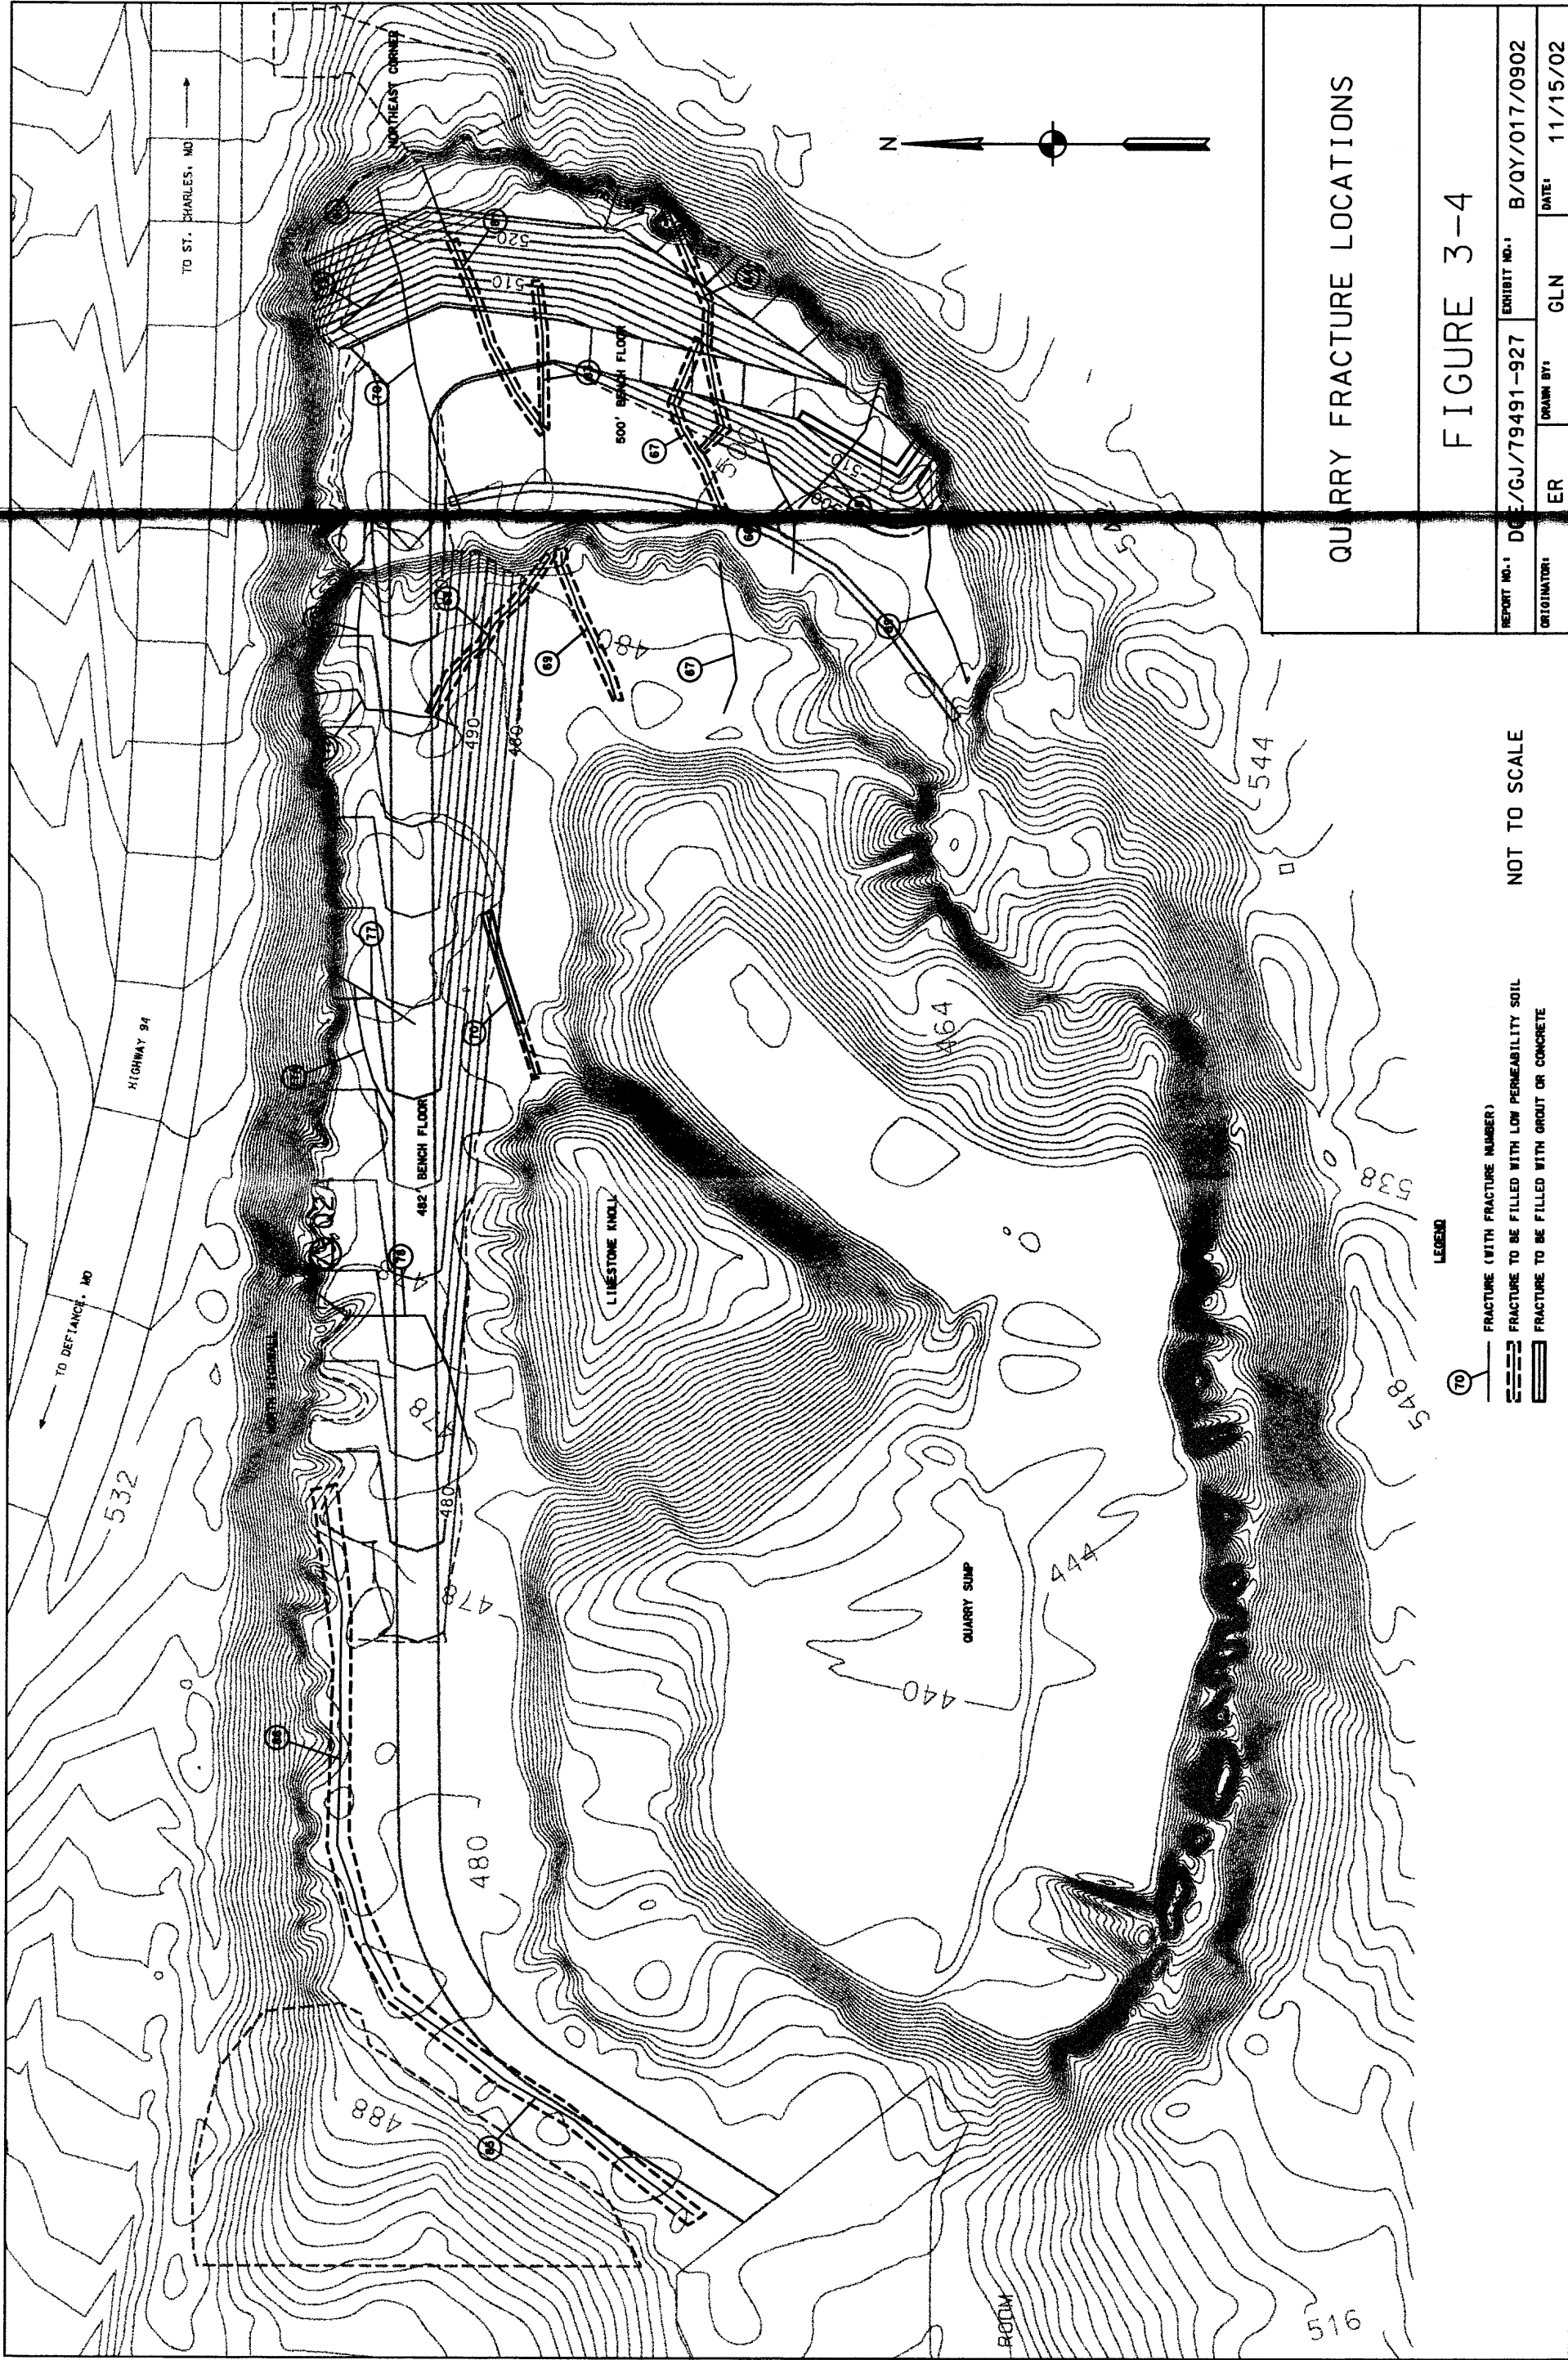
Several large aperture fractures were present on the floor and benches of the quarry floor. These large fractures were filled to reduce the possibility of soil piping and ultimately settlement of the final graded soil surface. Lower permeability clay materials and/or grout were used to backfill fractures. Some large vertical fractures were present in the north highwall that will require treatment to reduce soil piping and settlement. These fractures were filled with concrete.

Under WP-551A (Quarry Restoration), five fractures on the north end of the quarry were sealed with 30 yd³ of concrete. These fractures had been deleted from WP-505X (Contaminated Soil Removal) because of the ineffectiveness of the shotcrete and the current elevation at the time (section 3.3). With the increased elevation created under WP-551A, these fractures were now able to be formed in with plywood and sealed with concrete.

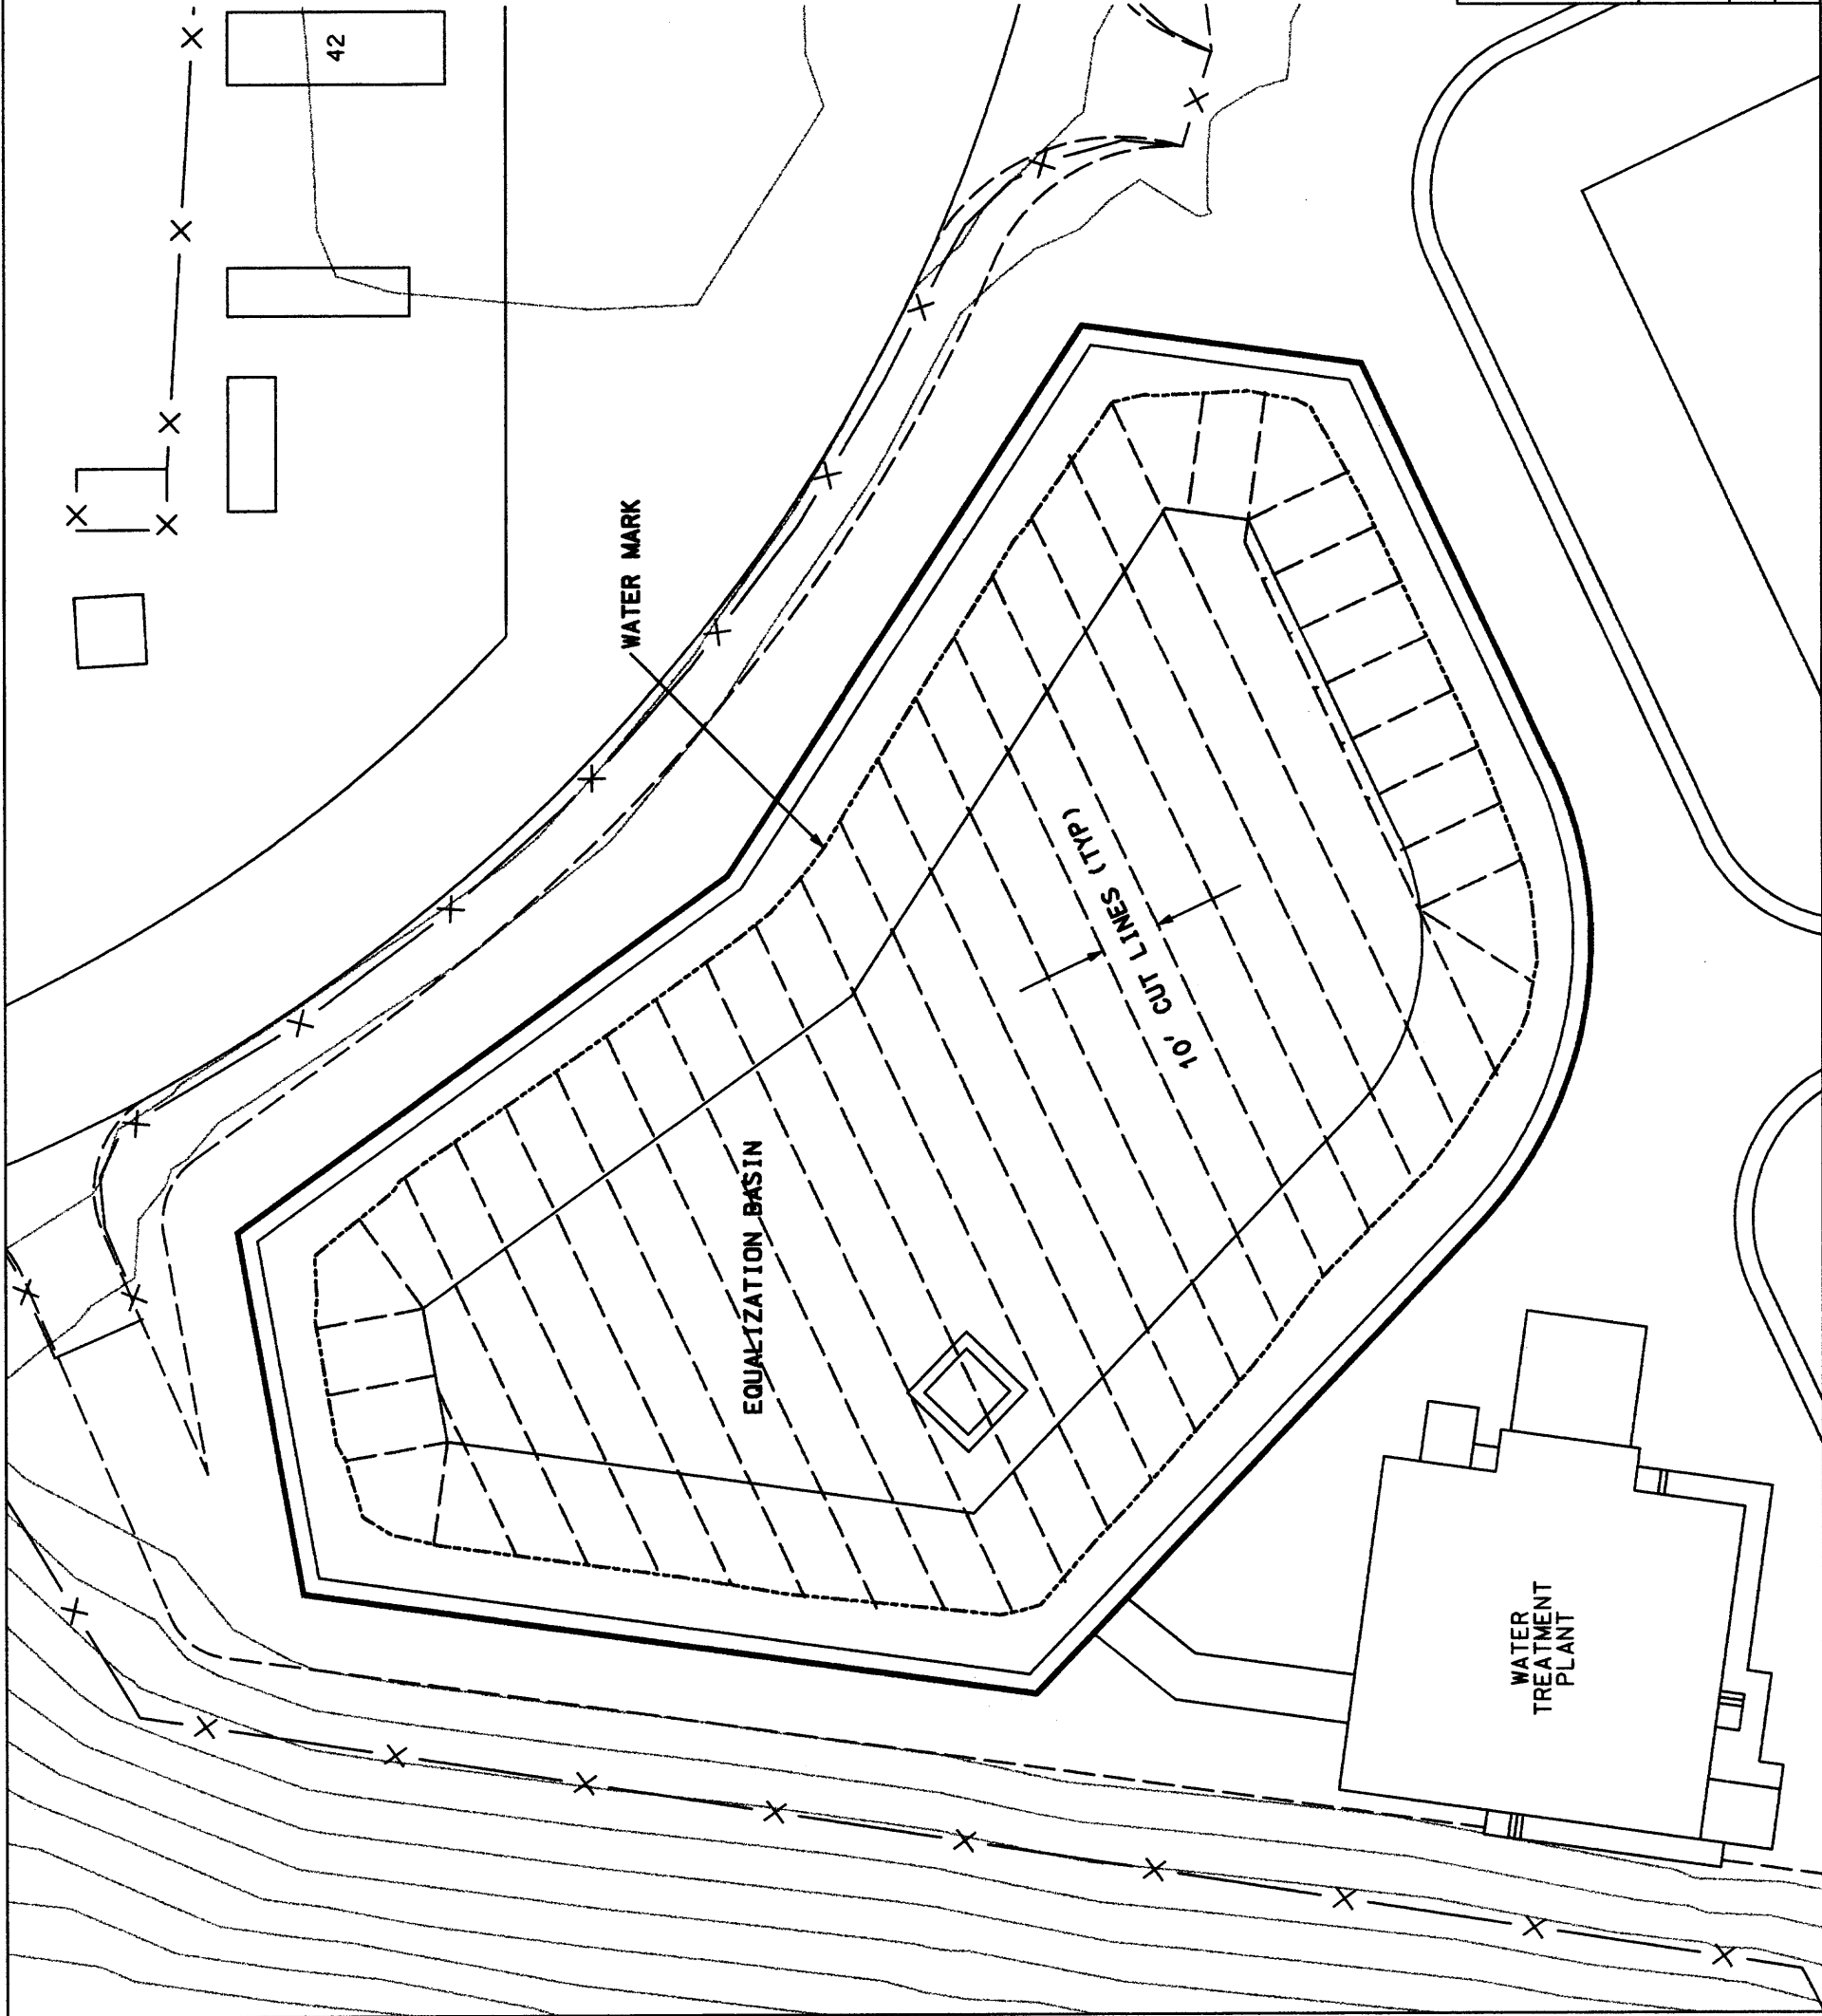
FIGURE 3-6

Removal of the Equalization Basin liner began on October 13, 2000, and was completed by November 14, 2000. Accumulated sediment in the Equalization Basin was removed and temporarily stored in containers. It was later mixed with soil and transported to the disposal cell. After removal of the sediment the first layer of liner was marked into 10' wide sections with spray paint (Figure 3-6). All HDPE liner and geogrid material above the designated water mark was determined to be at background and designated for disposal in a licensed landfill. The remaining liner/geogrid was designated as contaminated above background based on surveys, and targeted for disposal in the Chemical Plant disposal cell.

A Caterpillar 322 excavator with an extended boom and cutter attachment was mobilized by the subcontractor to remove the contaminated liner. The excavator was used to cut through the layers of liners and geogrid in one pass. After the liners/geogrid were cut, laborers using hand cutters, sized and packaged the material. The liner was packaged in bales using plywood and banding materials. The geogrid was rolled up and later unrolled in the disposal cell. The packages were lifted out of the basin with the excavator and transported to the staging area next to the quarry decontamination pad. Approximately 175 yd³ of geogrid and 30 yd³ of HDPE liner were staged for and disposed in the Chemical Plant disposal cell.

QUARRY EQUALIZATION BASIN

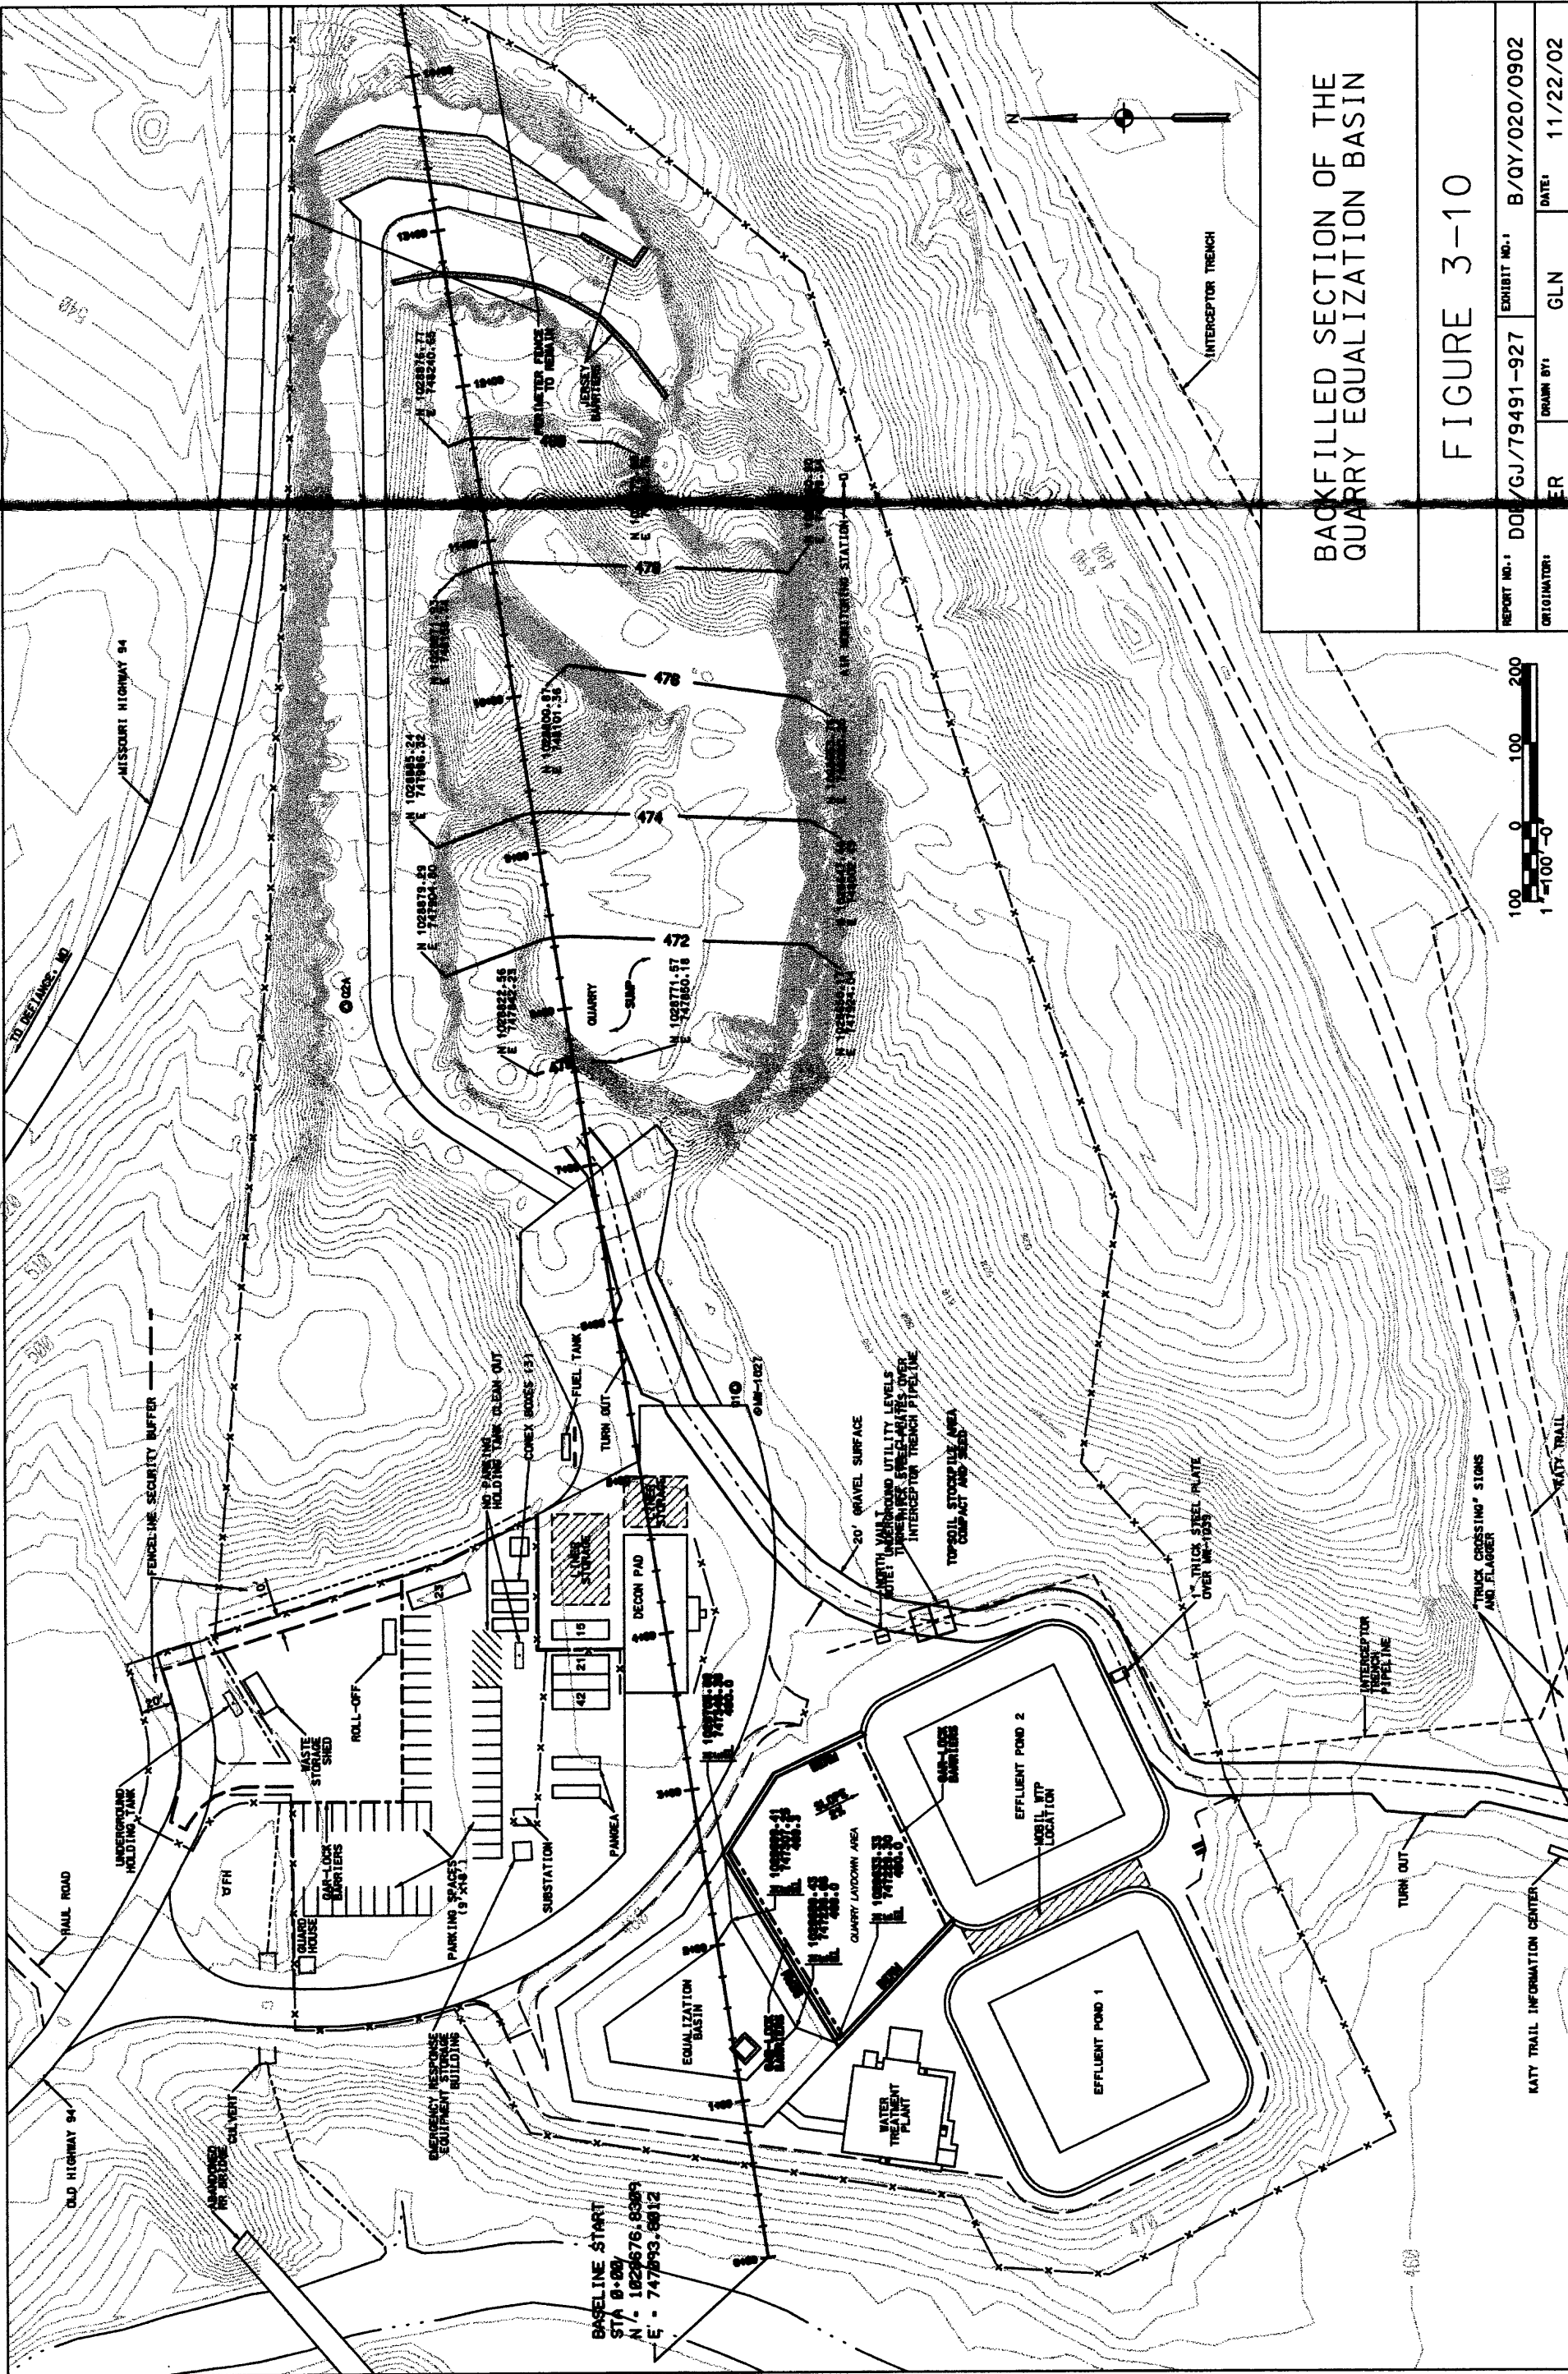
BACKFILLED SECTION OF THE QUARRY EQUALIZATION BASIN		
FIGURE 3-10		
REPORT NO.: D08/GJ/79491-927	EXHIBIT NO.: B/QY/020/0902	
ORIGINATOR: ER	DRAWN BY: GLN	DATE: 11/22/02
